Warm-water Point-intercept Macrophyte Survey Diamond Lake - WBIC: 2897100 Bayfield County, Wisconsin

Survey Conducted by and Report Prepared by:

Endangered Resource Services, LLC
Matthew S. Berg, Research Biologist
St. Croix Falls, Wisconsin
August 17-18, 2021

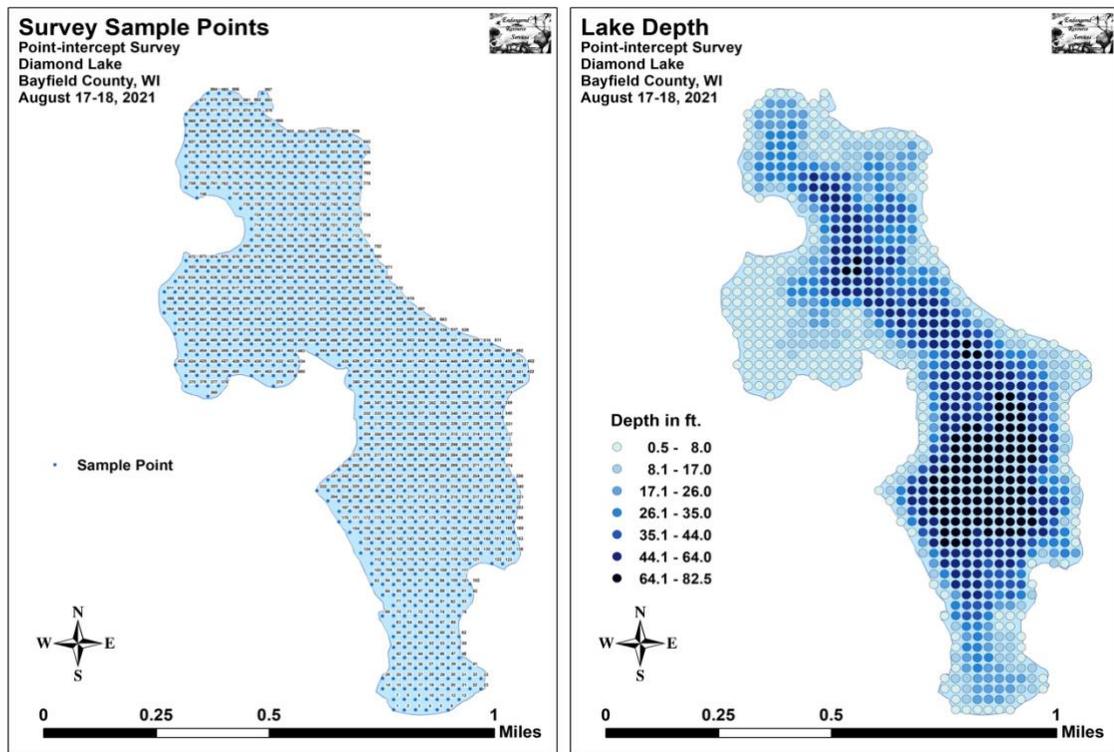
Figure 3: Survey Sample Points and Lake Depth

Depth readings taken at Diamond Lake's 887 survey points revealed a varied underwater topography (Figure 3). In the southern half of the lake, with the exception of the broad flat just north of the public landing, we found most shoreline areas had a narrow rim that extended out into 10-15ft of water before plunging into the deep trench that dominated the center of the lake. Conversely, most side bays in the northern half of the lake sloped gradually into 20ft+ before joining the central basin. Specifically, a broad shallow flat dominated the majority of the northwest bay, and the north bay contained a variety of shallow flats and rock humps including several small areas that were not shown on the WDNR bathymetric map (Appendix III).

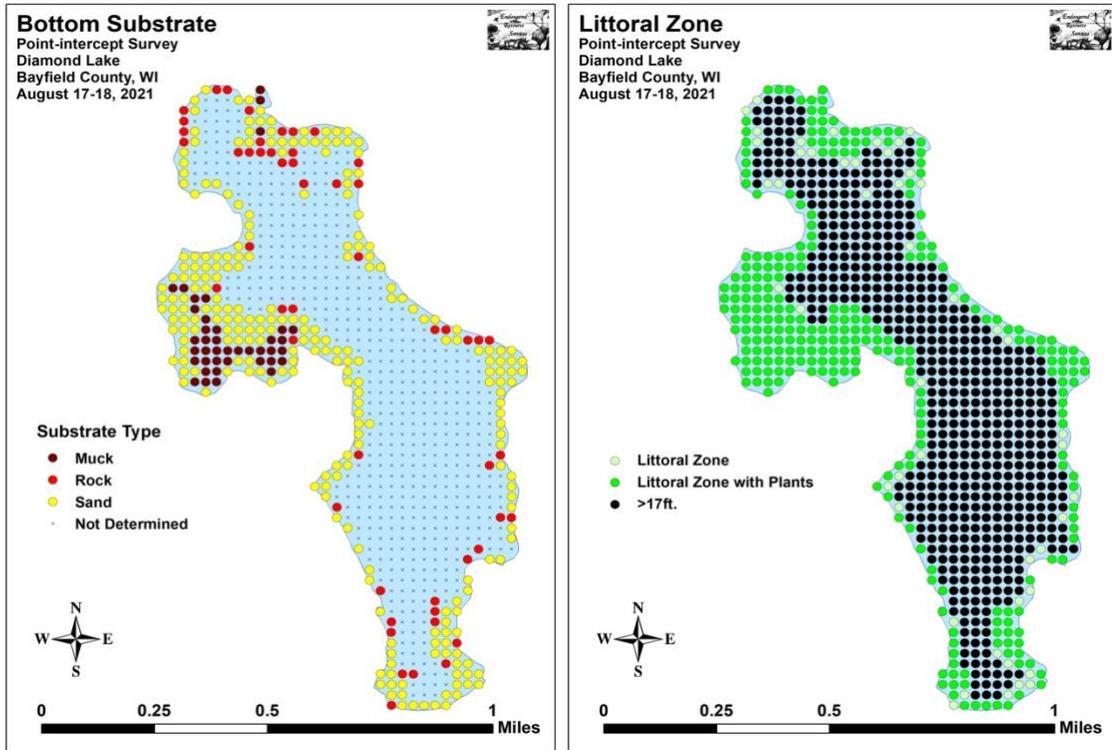
Figure 4: Bottom Substrate and Littoral Zone

Of the 339 points where we could determine the bottom substrate, we categorized 72.9% as pure sand (247 points), 15.3% as rock (52 points), and 11.8% as sandy or organic muck (40 points) (Figure 4) (Appendix III). The majority of areas along the immediate shoreline were pure sand or a mix of sand and gravel. With increasing depths, most areas tended to have a very thin layer of soft sandy muck over a pure sand base; however, we didn't classify these points as muck unless it was obviously more than a few inches thick. The only areas with nutrient-rich organic muck occurred adjacent to the Tamarack (*Larix laricina*), Black spruce (*Picea mariana*), and Leatherleaf (*Chamaedaphne calyculata*) bogs on the southern end of the northwestern side bay and in the small "nook" bay on the lake's north side.

We found plants growing at 277 points (Table 1). This extrapolated to 31.3% of the total lake bottom and 85.2% of the 17.0ft littoral zone (Figure 4) (Appendix IV). Overall plant colonization was strongly skewed to deep water as the mean depth of 6.1ft was much higher than the median depth of 5.0ft (Figure 5).

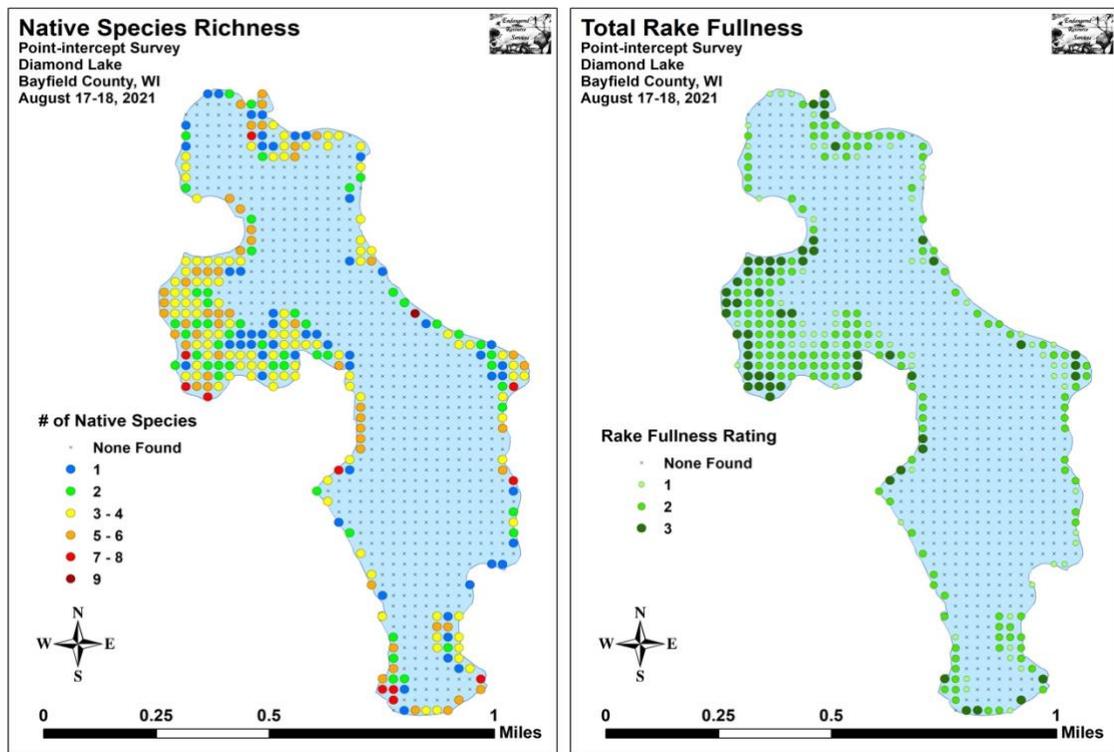
Figure 6: Native Species Richness and Total Rake Fullness

Localized richness was moderately high, and we calculated a mean native species at sites with native vegetation of 3.27 species/site. Most high richness areas were found along the immediate shoreline, and few deepwater areas had more than four species present (Figure 6) (Appendix IV).

We documented a moderate mean total rake fullness of 1.97. Visual analysis of the map showed that most of the areas with dense vegetation occurred in the north and northwest bays over nutrient-rich organic muck. In the southern half of the lake, most high-density points were located along the immediate shoreline where carpets of low-growing turf-forming species occasionally covered the bottom (Figure 6) (Appendix IV).

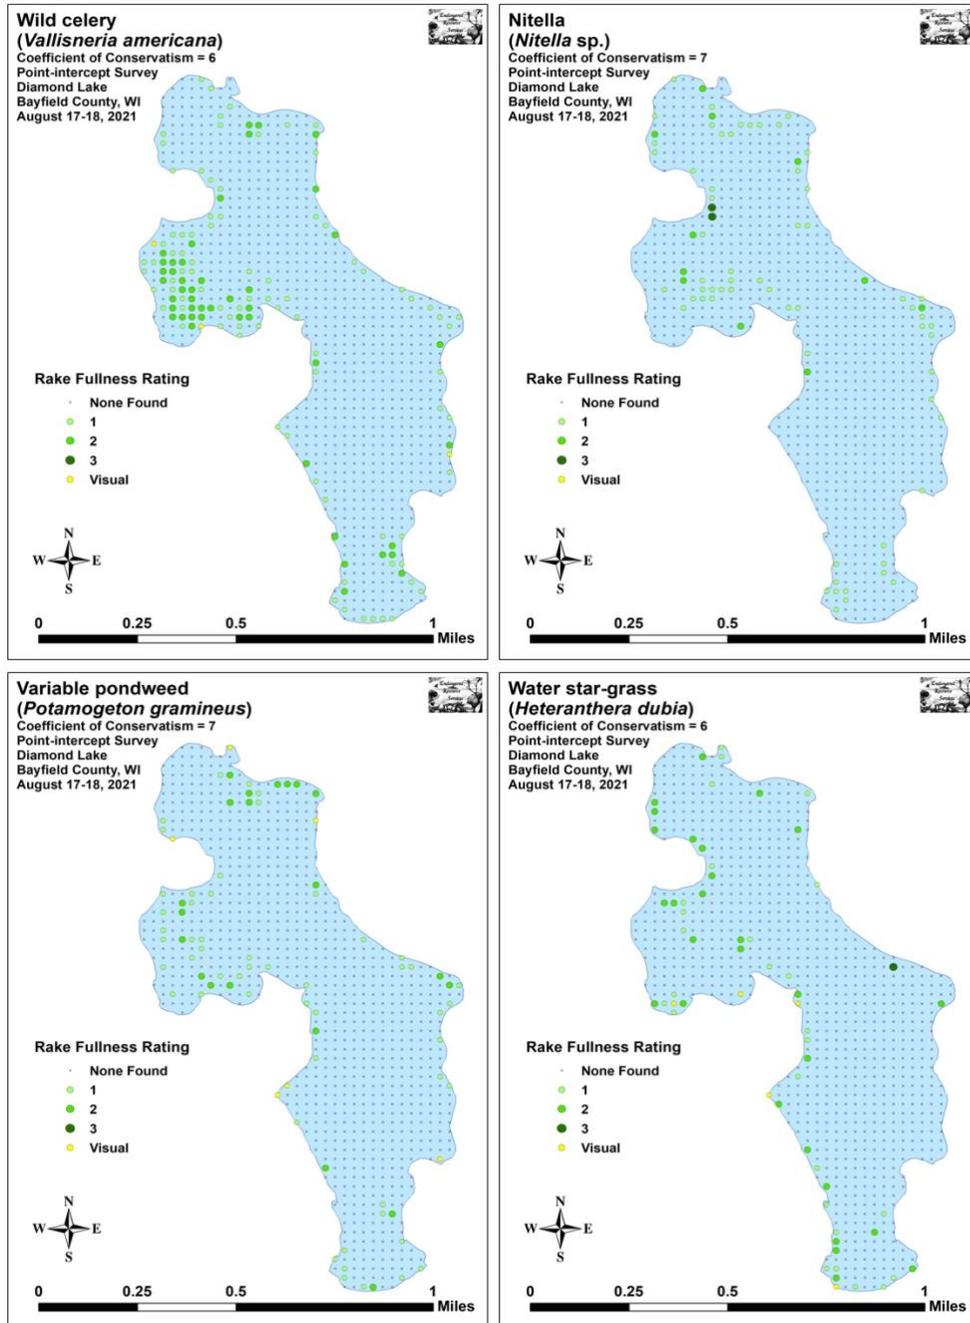
Figure 7: Diamond Lake's Most Common Species

When considering the lake as a whole, Wild celery, Nitella, Variable pondweed, and Water star-grass were the most widely-distributed macrophyte species. Present at 47.29%, 26.71%, 26.71%, and 20.22% of survey points with vegetation respectively, they collectively accounted for 37.02% of the total relative frequency (Table 2) (Figure 7). Muskgrass (5.08%), Creeping spearwort (4.75%), Dwarf water-milfoil (4.64%), Fern pondweed (4.64%), and Slender naiad (4.09%) were the only other species with relative frequencies over 4.00% (Maps and species accounts for all plants are located in Appendixes V and VI).

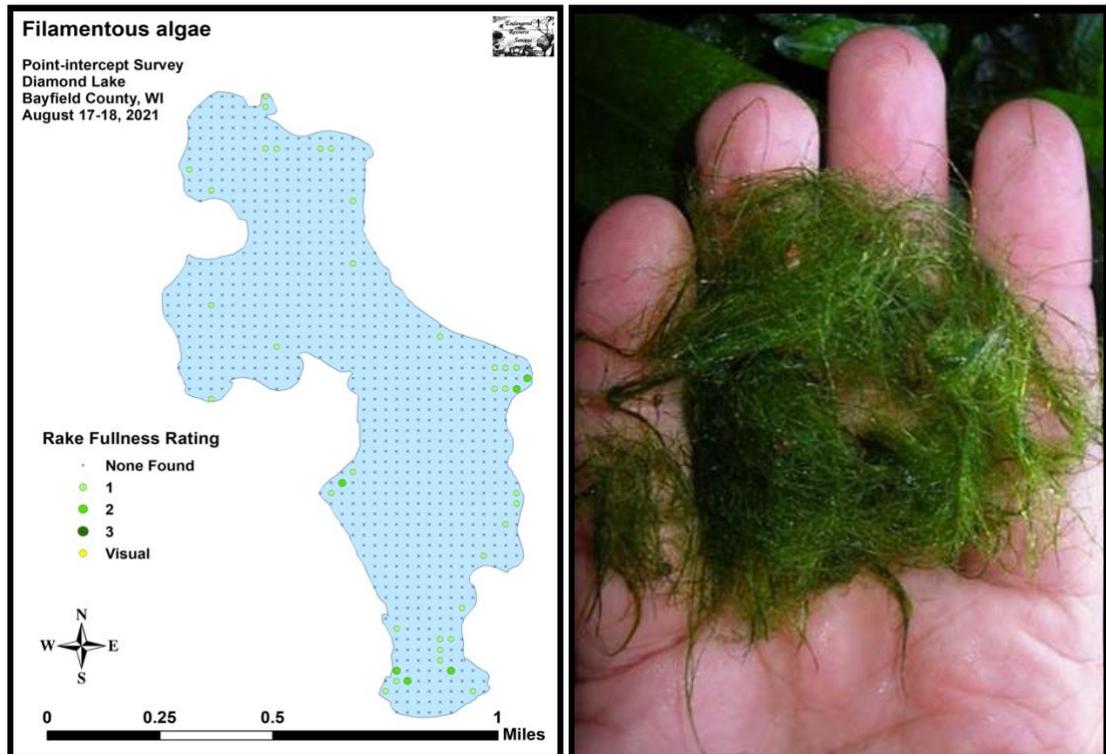
Figure 8: Filamentous Algae Density and Distribution

Filamentous algae are normally associated with excessive nutrients in the water column from such things as runoff, internal nutrient recycling, and failed septic systems. We found these algae at 40 points with a mean rake fullness of 1.15. Although present throughout the lake, most moderate density areas were scattered around the south bay and the east-central bay (Figure 8).

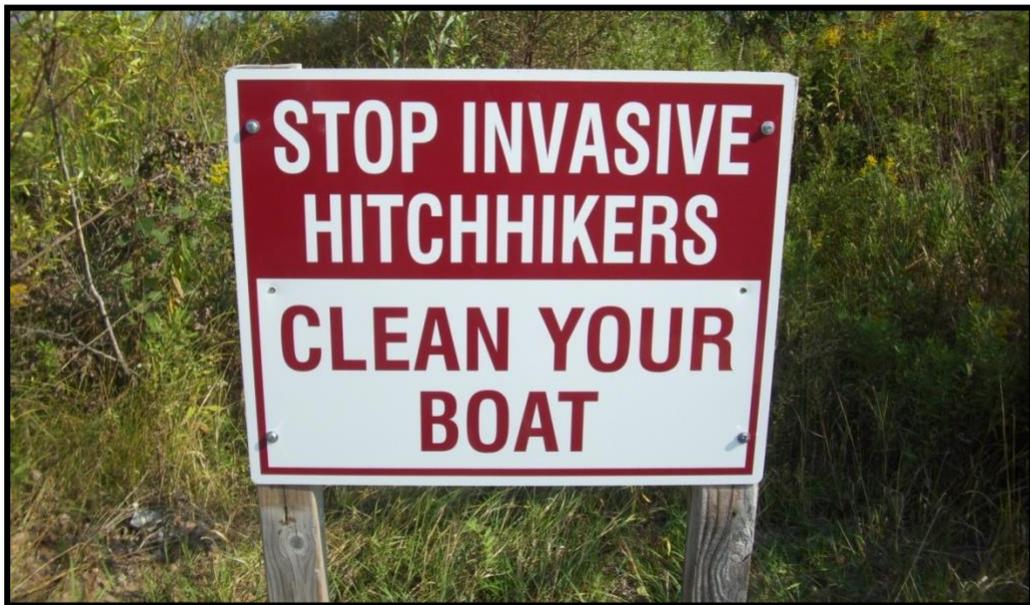
Figure 12: Potential Secondary Sign to be Placed Near the Water’s Edge

A small standard WDNR AIS sign and a motion-activated landing monitor with a recorded message are currently serving as the “guardians of the lake”. Adding a secondary sign that is located at the waterline is another potential actionable item for the DL to consider. Hopefully, a simple bright sign will increase the chances that visitors will remember to check their boat carefully before launching (Figure 12).
